A DEFENSIBLE COMMUNITY?

A Retrospective Study of Montecito Fire Protection District's Wildland Fire Program during the 2017 Thomas Fire

October 23, 2018

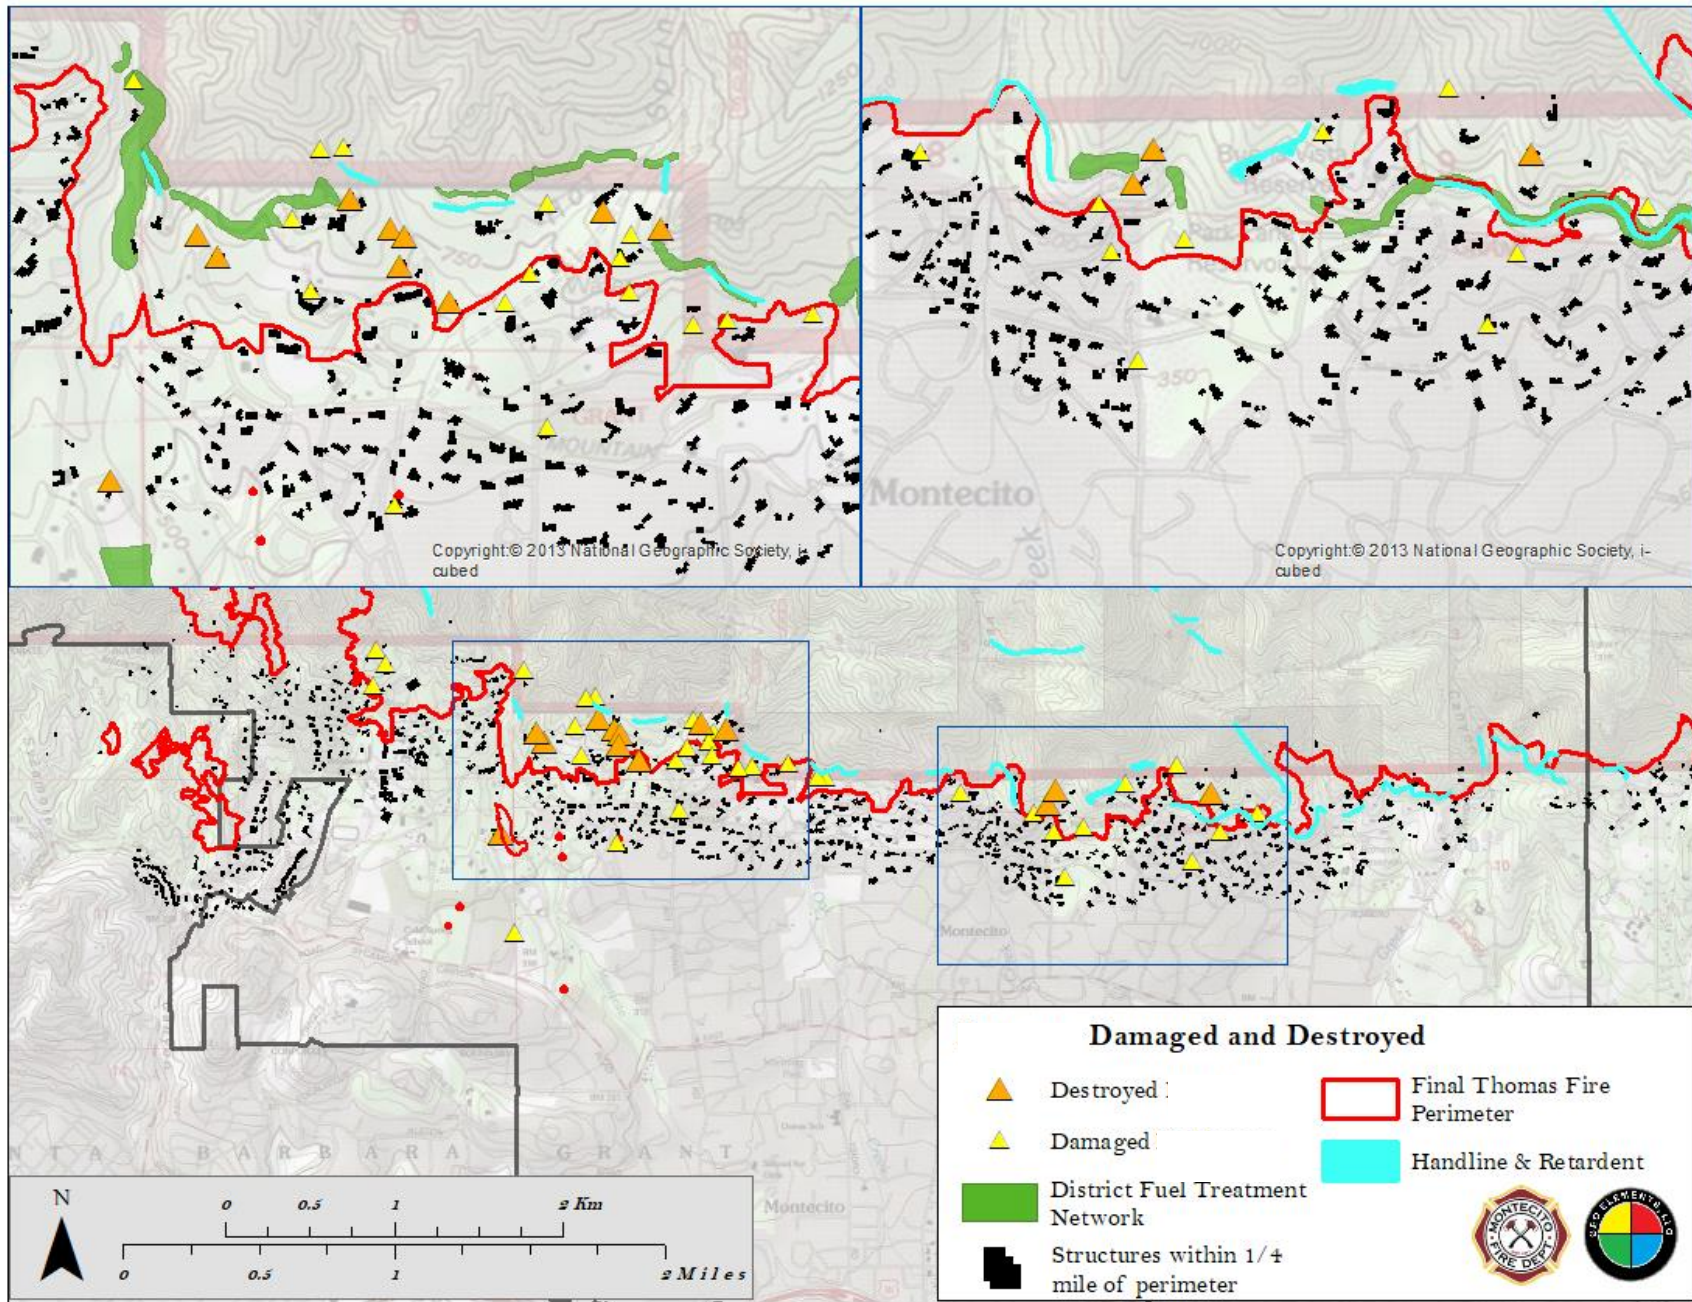
Figure 8 PDU and ADUs Damaged and Destroyed Map

Finally, it is also notable that two of the PDUs and three of the ADUs destroyed were located below a gap in the Montecito fuel treatment network, just west of Hot Springs Road. This gap was identified by the District's Wildland Fire Specialist as a potential point of weakness in the fuel treatment network prior to the Thomas Fire. Unfortunately, this gap aligned with the primary fire front as it moved into the community on December 16th. All five of these destroyed PDUs and ADUs were surrounded by dense vegetation, with trees overhanging the driveway and homes, and it is likely that these structures were exposed to substantial ember wash, intense heat, and direct flame impingement.

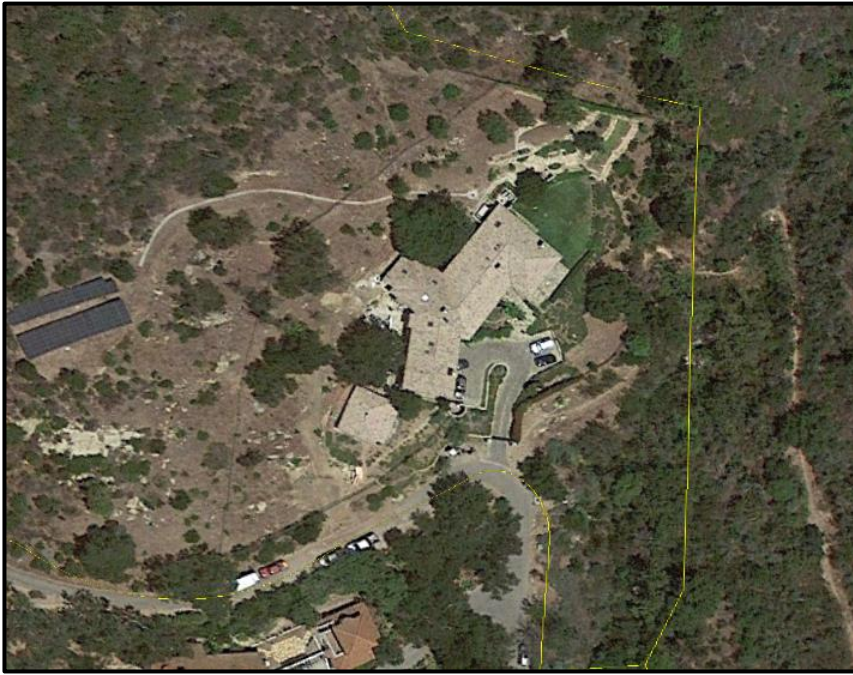
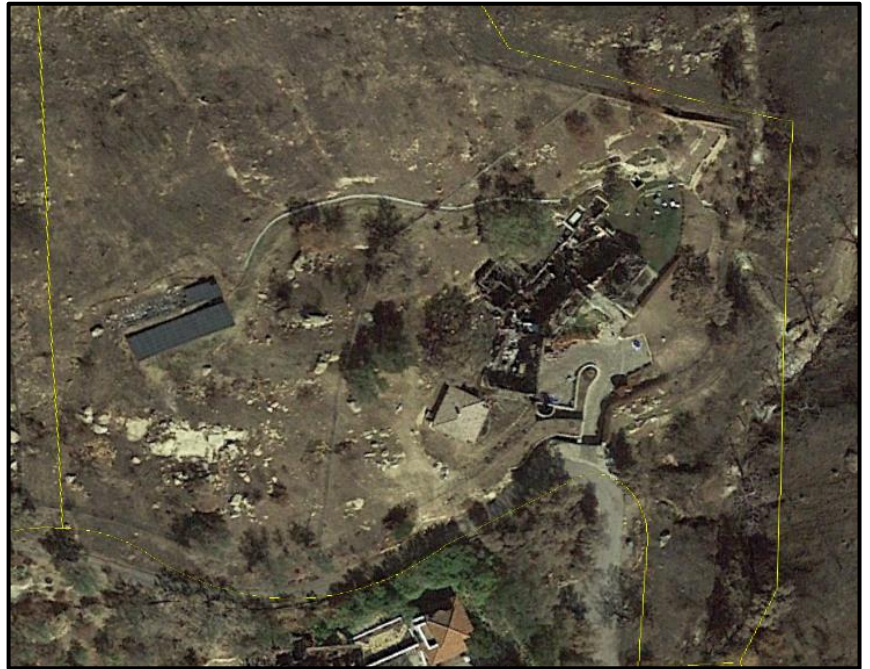
Park Hill Lane - pre-Thomas Fire (Source: Google Earth)

The PDU sits next to a steep draw with dense fuels pre-Thomas Fire (see images below). An interviewee indicated that the fire moved down into this draw and generated substantial fire intensity in the heavy fuels. Several interviewees stated that Park Hill Lane was not a road where they felt safe conducting firefighting operations. Park Hill Lane is a narrow, winding dead end street that lacked an adequate turn around area for fire apparatus at its upper end. It is likely this PDU had either direct flame impingement from the vegetation on the east side or ember impingement on the east side. The property-owner could not improve defensible space to the east due to a riparian area (See following page for images).

Park Hill Lane – This PDU was built in 1965 and was built with non-combustible roof and siding material and had dual-pane windows. There was considerable green vegetation around the PDU pre-fire with imagery showing that this vegetation was immediately adjacent to the PDU. No evidence of hazard reduction clearing is discernable from the imagery. This location is a candidate for ember ignition as the source of its damage. Firefighters were unable to conduct fire following structure defense operations due to unsafe nature of Park Hill Lane.

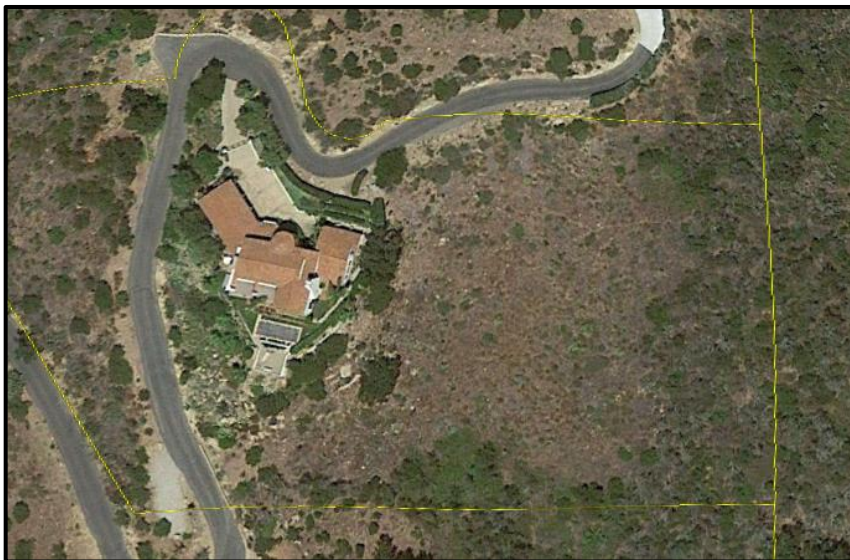
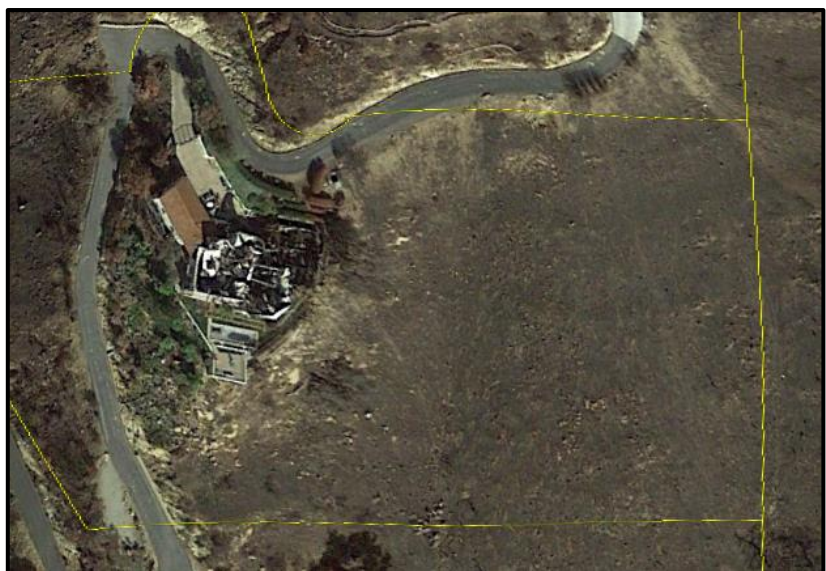
Park Lane - pre-Thomas Fire (Source: Google Earth)

Park Lane – Built in 1998, the PDU was destroyed in the fire. No information on the type of construction material used at this property is available. Interviewees indicated that the backing fire affected this location, so it is unlikely that severe fire behavior contributed to the loss of the PDU. The property-owner had cleared substantial vegetation on all sides of the structure, up to about 60m (200 feet) on the downhill/east side; however, substantial green vegetation was retained directly adjacent to the PDU. This structure most potentially ignited from ember cast, and firefighters speculate that the property-owners likely left a window or garage door open allowing embers to enter the structure. The vegetation on the west side of the PDU did not burn and remained green while it appears that the vegetation on the east side of the structure burned due to the structure burning. The PDU was located toward the end of a long, narrow drive and lacked an adequate turn around for fire apparatus.

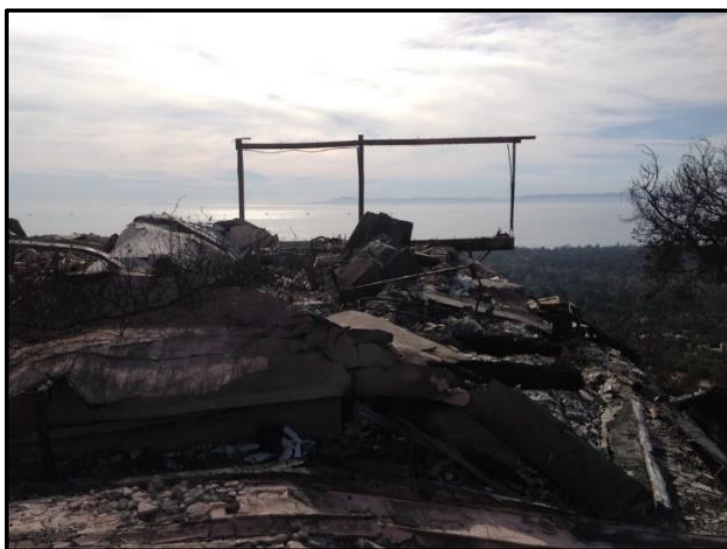
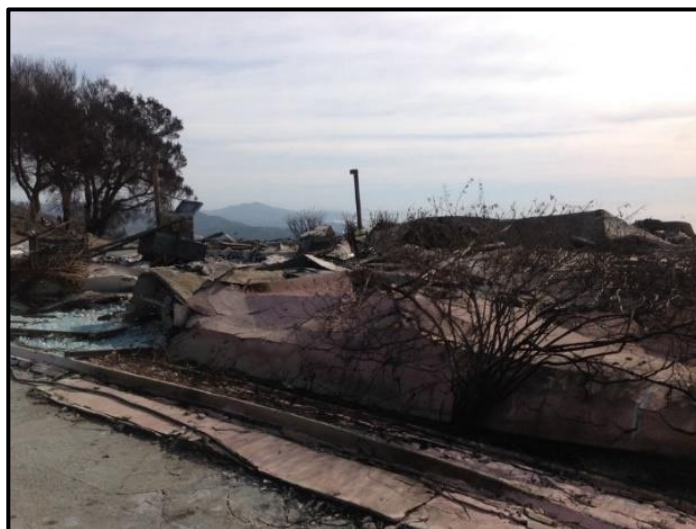
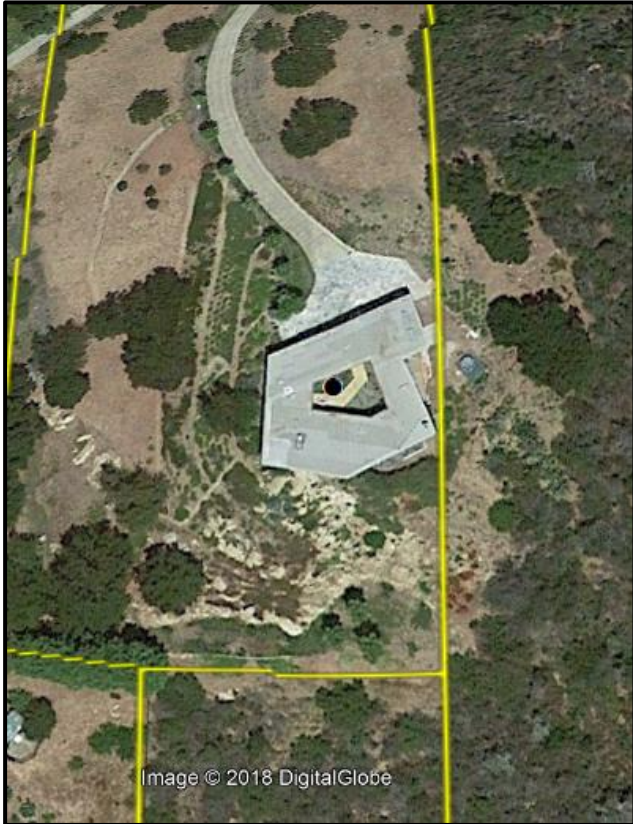
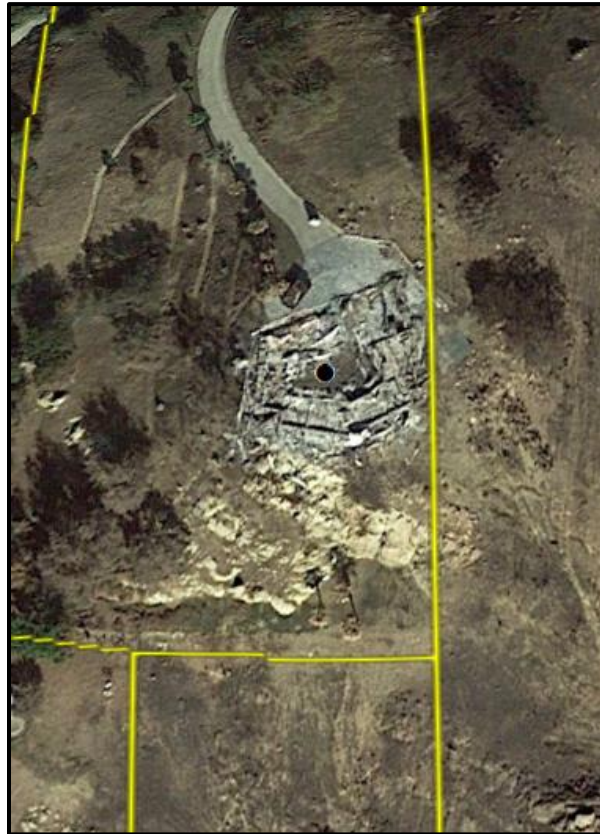
Hot Springs Lane – Built in 1984, the PDU was destroyed. No information on construction materials is available. The PDU was located at the end of a long and winding driveway that lacked an adequate turnaround for fire apparatus. Property-owners had cleared substantial vegetation away from the structure, approximately 30m (98 feet) on three sides (north, west, and south) but only 5-10m (16-33 feet) on the east side due to property line constraints. Aerial imagery indicates that the pentagon shaped structure had a courtyard in the center of the building. In the aerial photo, vegetation is visible within the courtyard. Much of the cleared area around the structure had been type converted to grass with several large trees/shrubs retained, including some vegetation immediately adjacent to the structure. The high fuel density immediately adjacent to the east could have produced considerable fire intensity and ember cast. Two scenarios are probable regarding the destruction of this structure; ignition occurred in the courtyard from embers or the ignition of the structure is a result of fire in the vegetation immediately adjacent to the east of the PDU.

Hot Springs Lane - PDU destroyed

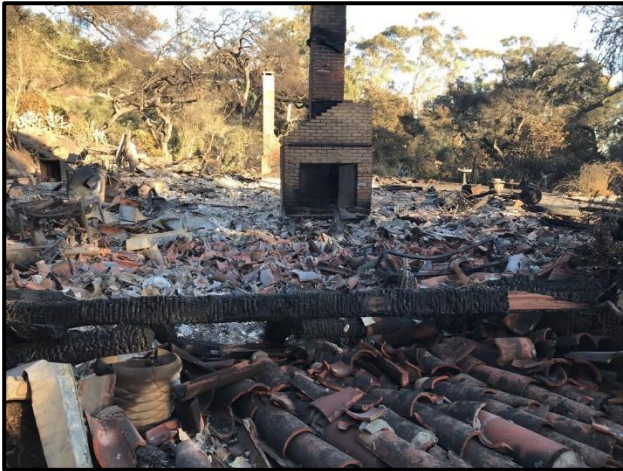
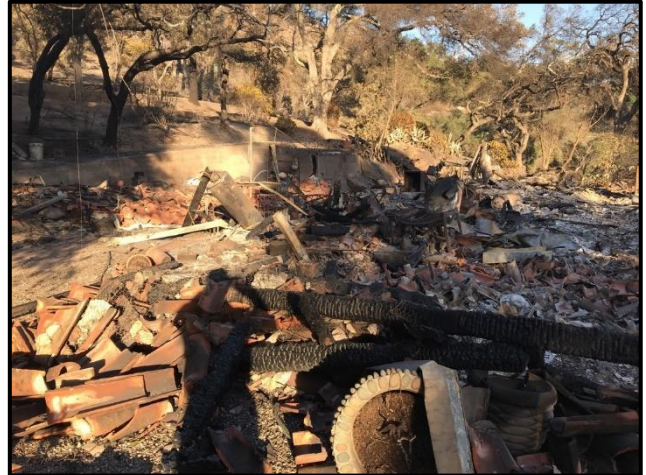
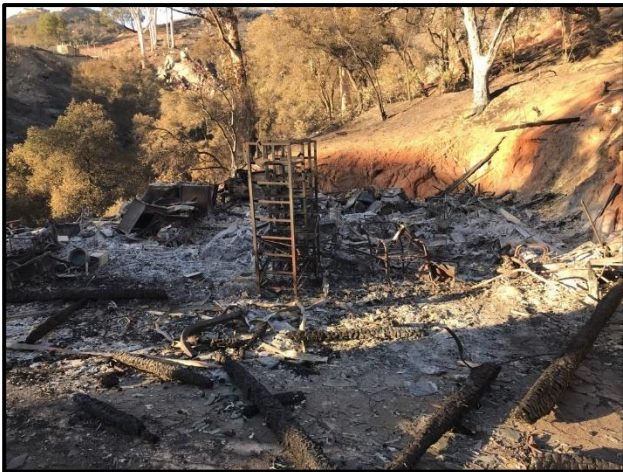
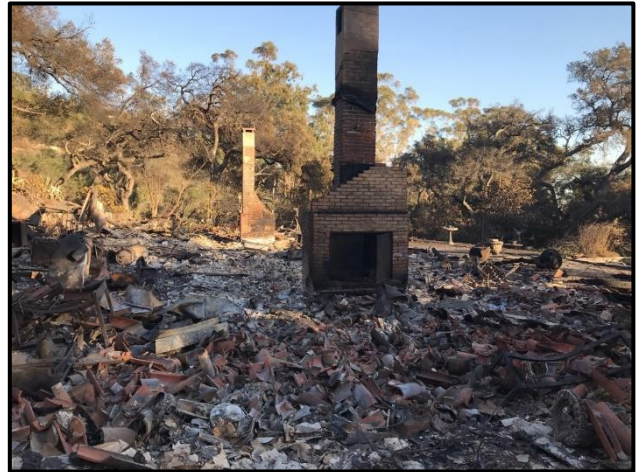
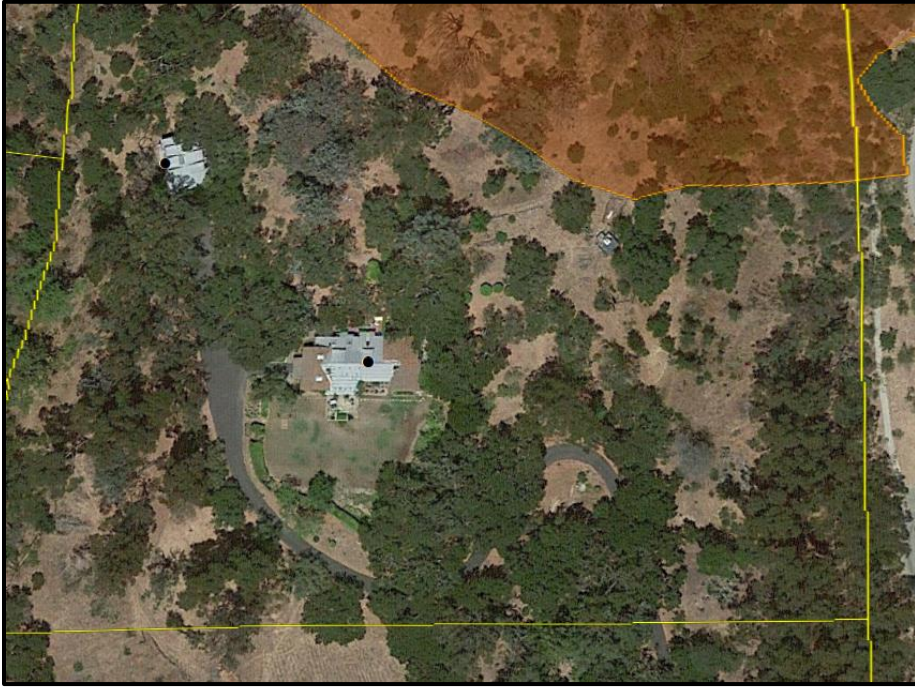
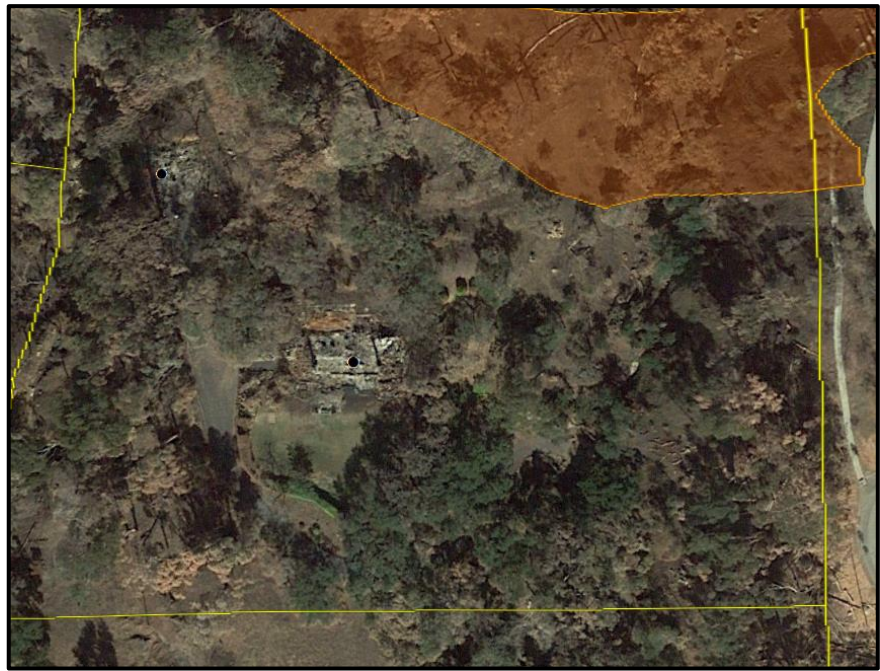
East Mountain Drive – Both the PDU and ADU were destroyed. Built in 1902, the PDU was primarily wood construction with a Spanish tile roof. The property had extensive fuels reduction done upslope of PDU pre-fire; however, there was considerable vegetation remaining immediately adjacent to PDU. Many trees around the PDU and ADU survived the fire, suggesting ember ignition in building materials. The property-owner indicated that there was substantial debris around the structures, which was currently being used as a rental property. The property had poor access and no turnarounds for fire apparatus.

East Mountain Drive – PDU and ADU destroyed

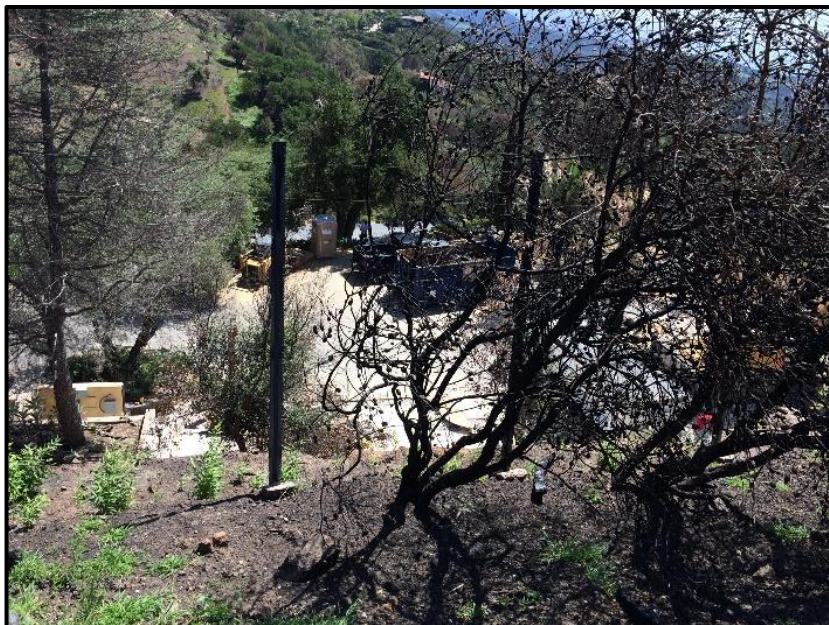
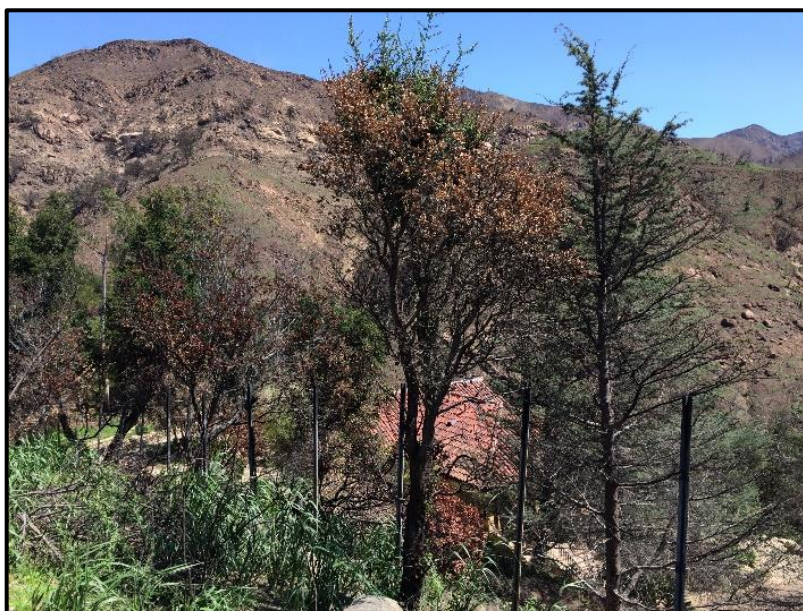
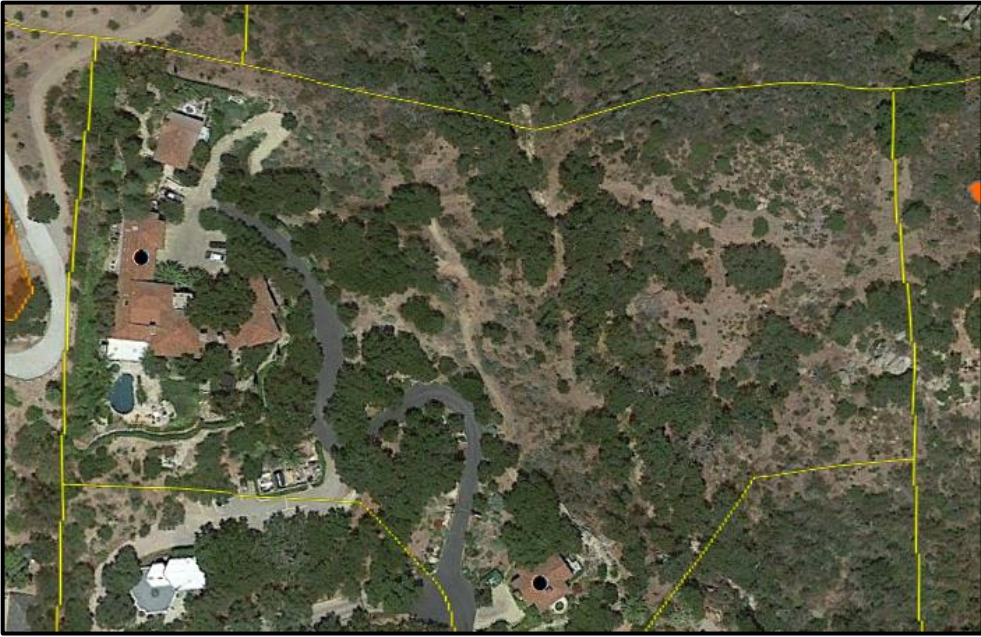
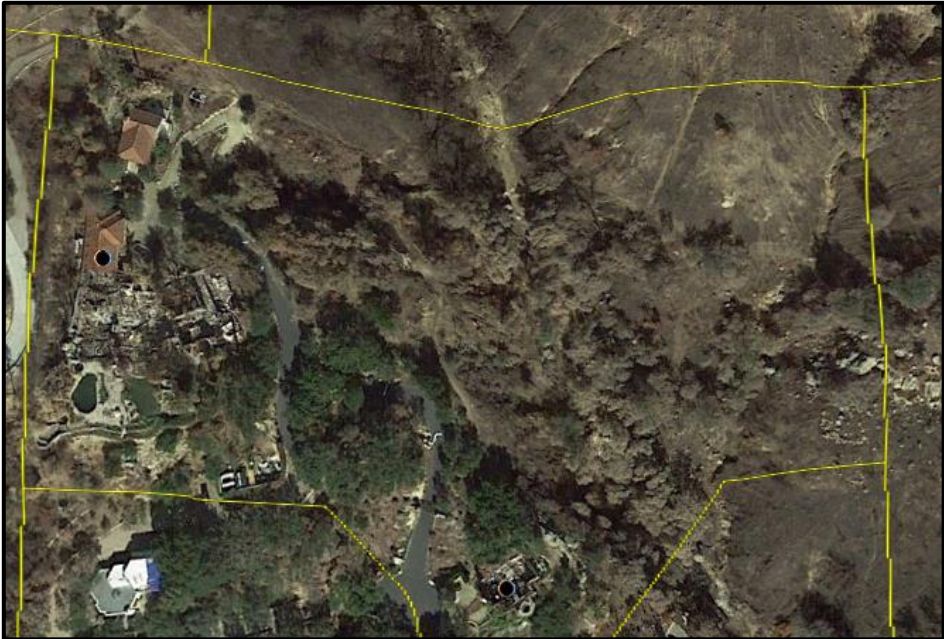
East Mountain Drive – Built in 1993 of unknown materials, both the PDU and ADU were destroyed. Based on visual assessment, the structures had Spanish tile roof. This property had been identified by District staff as a structure at risk as geographically; it straddled a drainage and was in close proximity of untreated fuel along the north edge of Montecito. Some fuel treatment had been occurred pre-fire in the vicinity of an old trail; however, considerable vegetation remained before the fire with little discernable defensible space. The property also had poor road access with no turn around location for fire apparatus.

East Mountain Drive – PDU and ADU were destroyed

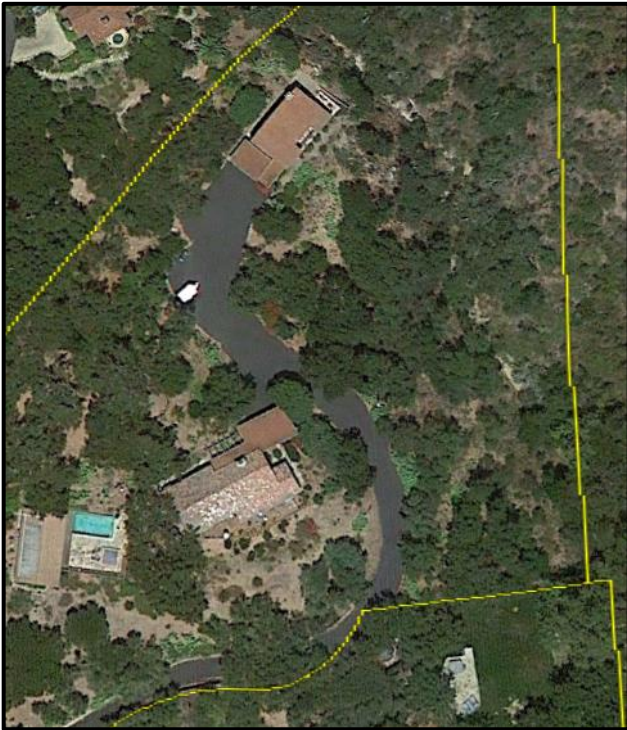
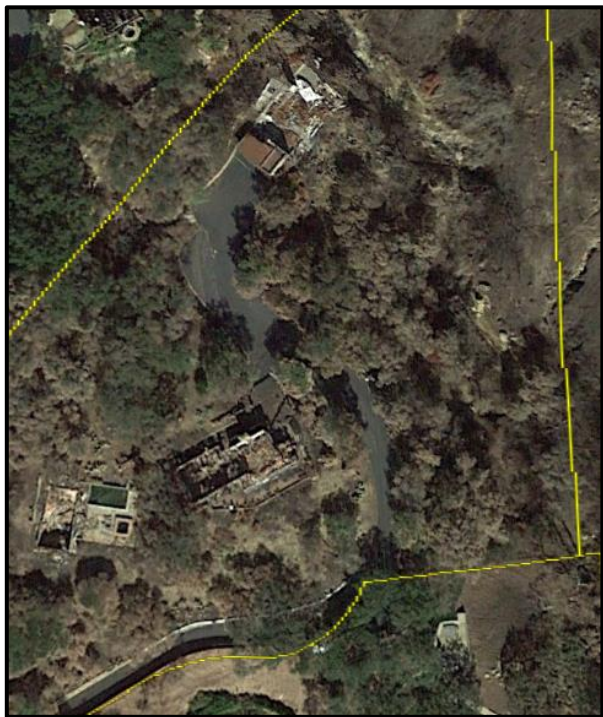
East Mountain Drive - pre-Thomas Fire (Source: Google Earth)

East Mountain Drive – Both the PDU and ADU were destroyed. The original structure built in 1984, did not show evidence of having been updated since the original construction. Prior to the fire, heavy vegetation surrounded both structures with no evidence of defensible space. Topographically, the structures were located on a bench above an adjacent drainage. Significant tree scorch and tree mortality is evident in the post fire imagery. This suggests that direct flame impingement from an intense surface fire combined with poor access for fire apparatus likely lead to the loss of the PDU and ADU.

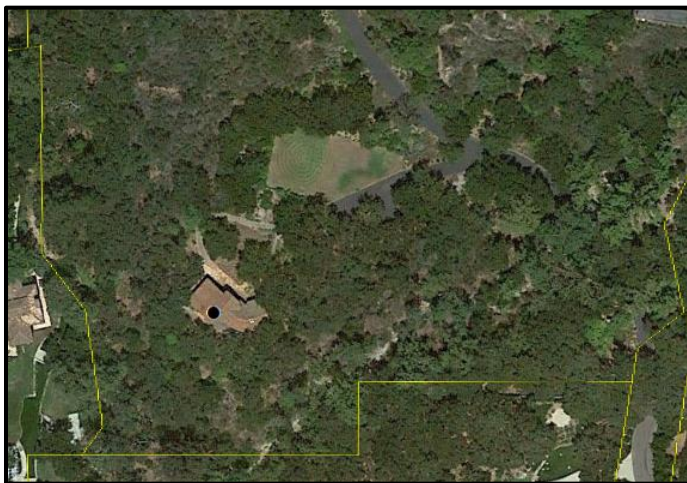
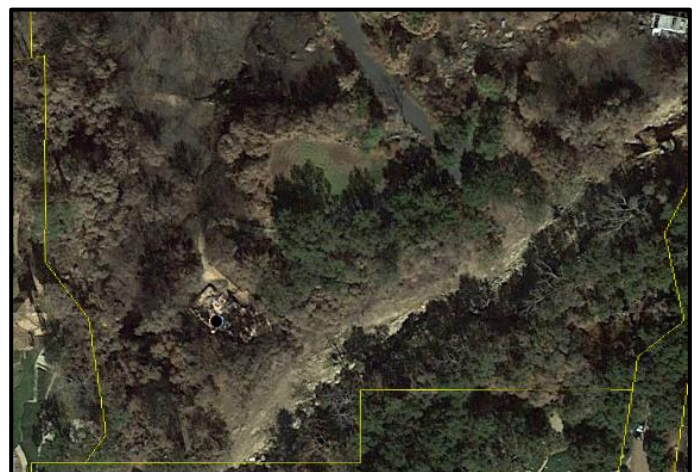
Hot Springs Road - pre-Thomas Fire (Source: Google Earth)

Hot Springs Road – The PDU was undamaged by the Thomas Fire while the ADU (guest house) was destroyed. Interviewees also noted that a bridge and a pump house were destroyed by the fire. Imagery indicates little or no defensible space around the ADU with heavy fuels located in the drainage below the structures. Evidence suggests a high intensity fire developed adjacent to ADU as the vegetation was completely consumed in the fire. Visual evidence suggests that direct flame impingement teamed with poor access and no turnaround areas for fire apparatus contributed to the destruction of this ADU.

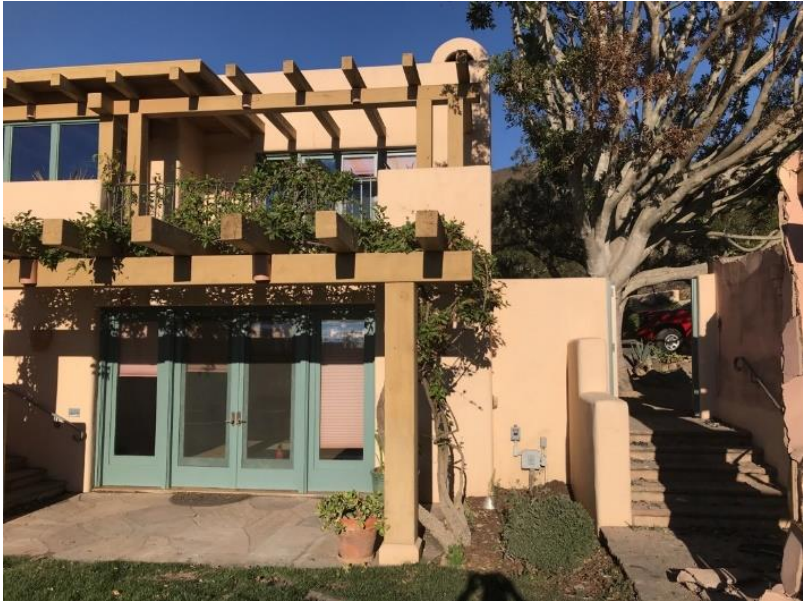
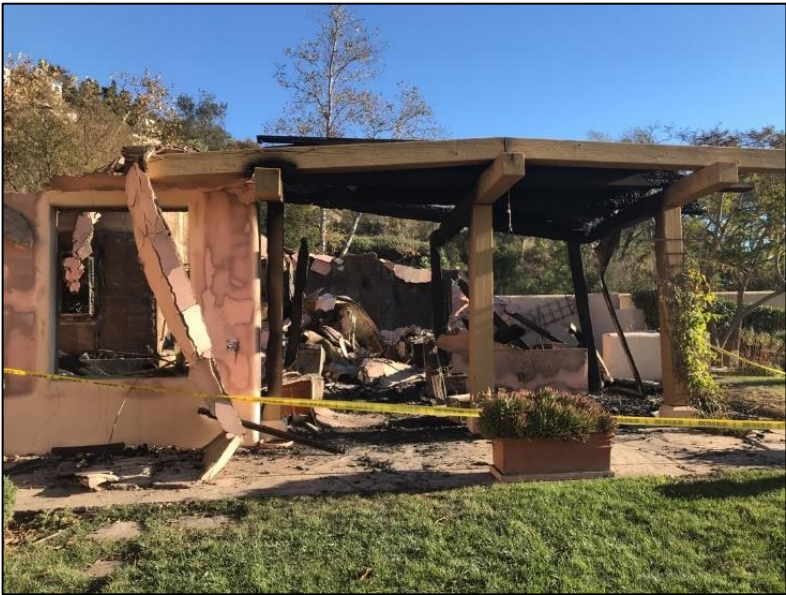
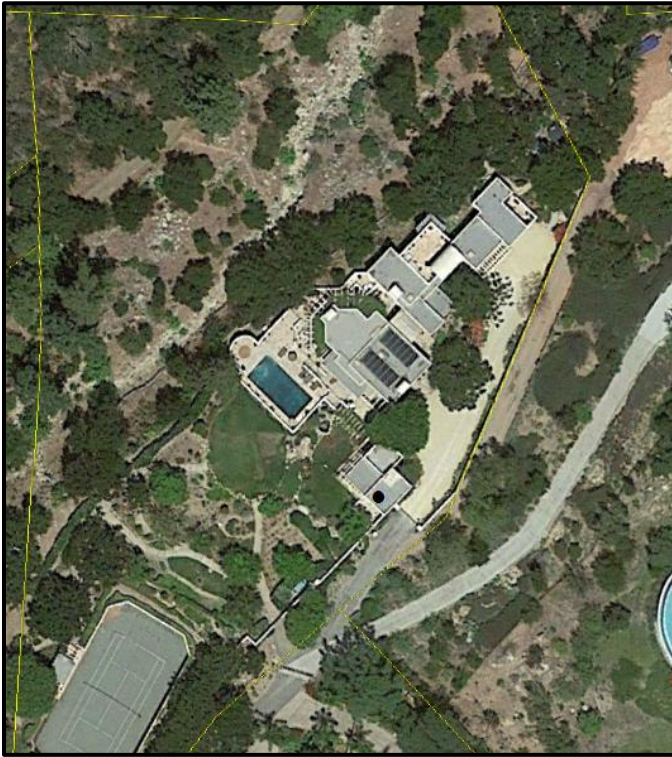
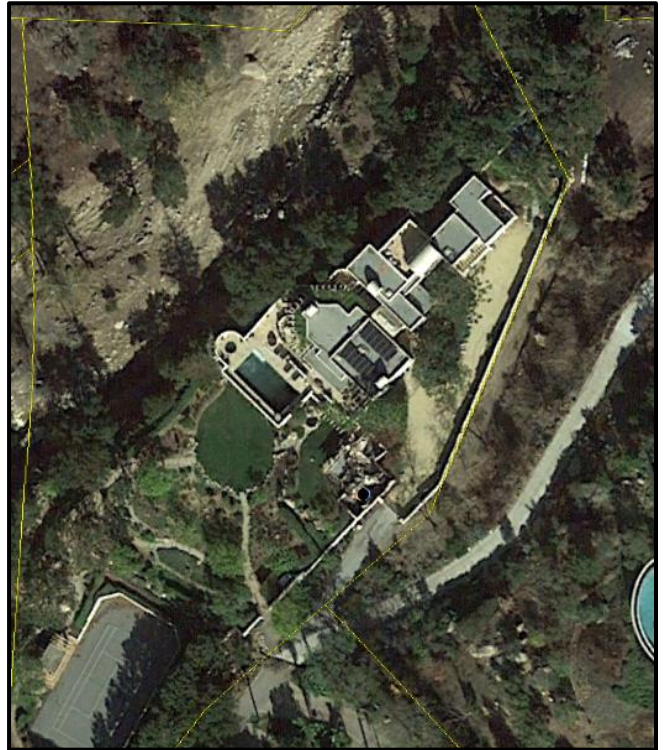
Hot Springs Lane – Built in 1989, the PDU was undamaged in the fire while the attached pool house was destroyed. Construction material consisted of a non-combustible siding and roof and dual-pane windows. The structure did have flammable structural component attached. Some defensible space is identifiable on the southwest side of the ADU, and it appears that the property-owner had thinned the brush up to the property line on the northwest side of the property. Considerable vegetation (shrubs and trees) remained immediately adjacent to the ADU but most vegetation adjacent to the destroyed structure was green after the fire suggesting that this was an ember ignition.

Hot Springs Lane - ADU was destroyed but the PDU survived

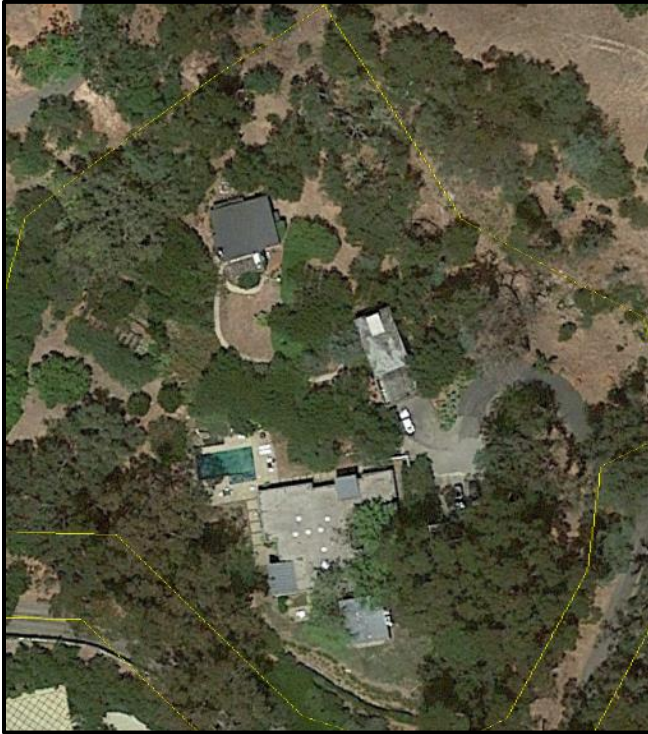
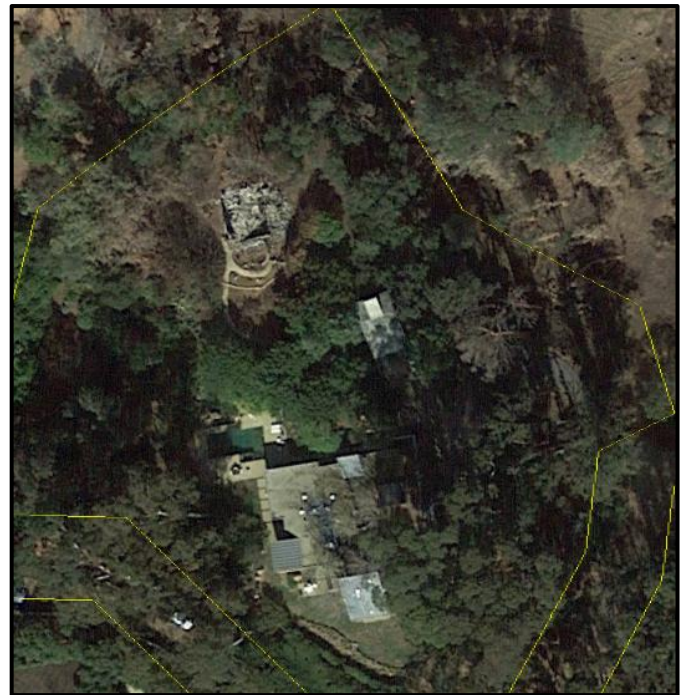
East Mountain Drive - pre-Thomas Fire (Source: Google Earth)

East Mountain Drive – The ADU was destroyed while no damage occurred to the PDU. Parcel data indicates the ADU was built in 1974 (likely had been a PDU). Immediately adjacent to the Thomas Fire perimeter, the fire was stopped between the ADU and PDU. Pre-fire imagery indicates that there was no defensible space, with an approximately 80% cover of dense vegetation around the ADU and PDU and on the property as a whole. This vegetative cover included mature oak and eucalyptus trees. The amount of green vegetation associated with this property post-fire suggests either ember ignition or impingement of the flaming front.

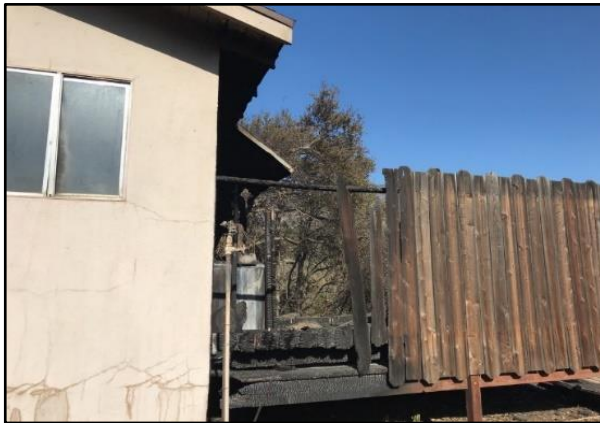
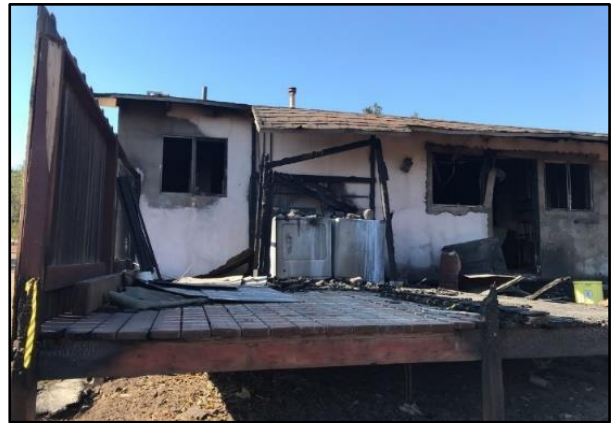
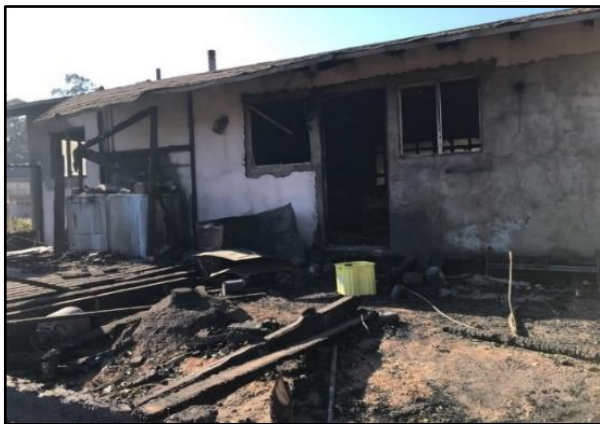
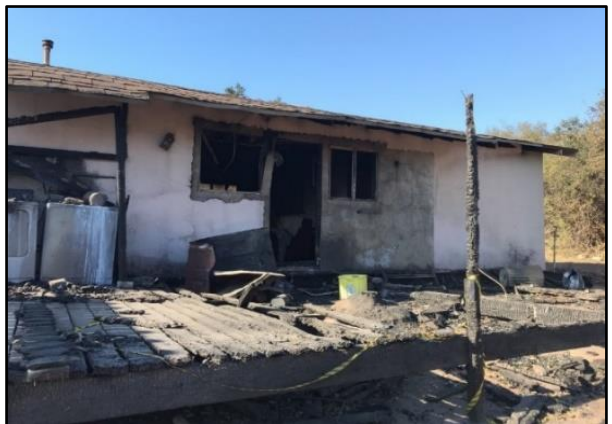
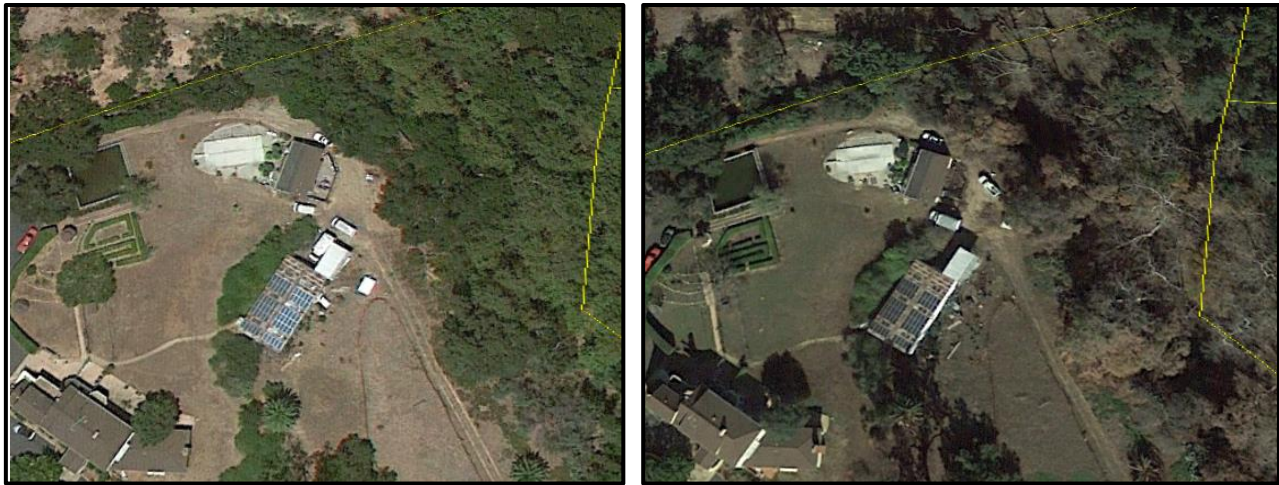
Ashley Road - post-Thomas Fire (Source: Google Earth)

Ashley Road - ADU was destroyed. This does not appear to be the PDU on the property but may have been the original homestead. This structure was built in 1900 and had a combustible roof, single-pane windows, non-combustible exterior siding (stucco or concrete), a wood deck, and unscreened vents. ADU was on flat ground and had less than 5m (16 feet) of defensible space. The ADU sat next to the Cold Spring Creek drainage with considerable riparian vegetation on the eastern side of the ADU and with a driveway separating the ADU from the vegetation. This ADU was likely ignited by embers, as photos show the wooden deck and fence partially consumed and a space underneath the deck. Debris build-up under a deck is common and ignitions from embers can easily occur in this debris. Additionally, there is evidence of debris on the deck that could have easily ignited and then supported ignition of the doors and/or entry through a broken window from fire intensity igniting burnable material within the ADU.

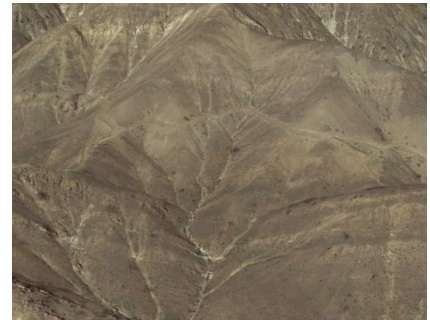
1) While the chaparral ecosystem in the area is primarily comprised of rapid re-sprouters that are fire-adapted, there was minimal re-sprout occurring on the slopes above Montecito. This is unusual, particularly as the area had received winter rains and the timing was such that re-sprouting was anticipated. The team observed entire slope patches with no visible green vegetation and no blackened shrub stumps (See Figure 9). This leads to the conclusion that even the fire-adapted shrub species were so drought-stressed and so much of the area burned at such high severity (with such low soil moisture present) that the fire induced widespread mortality of plants.

Figure 9 Aerial view of a mid-slope location above Montecito where some of the most intense fire activity occurred.

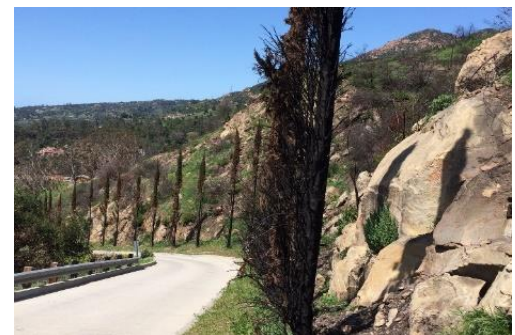
4) Cypress is another non-native tree that is widely used for landscaping and screening in the Montecito area. In contrast to the fire-resistance we observed in some eucalyptus, cypresses were consistently consumed throughout the impact area; often well away from the fire edge. This suggests that cypress were highly susceptible fuels to the ember showers observed during the Thomas Fire. Further, many of the damaged PDUs and ADUs had burned cypress trees as the source of the flame damage, suggesting that this species is a very poor choice for landscaping within the defensible space zone.

Figure 10 Cypress trees burned during Thomas Fire

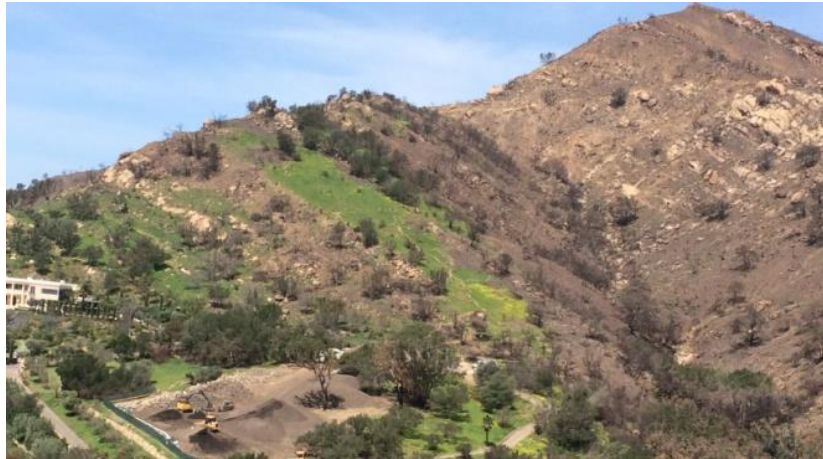
- 5) By contrast to the areas above Montecito where high severity fire completely consumed all vegetation across large slope patches, areas where some fuel reduction had occurred prior to the Thomas Fire had lower severity fire effects. Across much of the uppermost built area of Montecito, both property-owners and the District had conducted thinning and fuel reduction activities (see Figure 11). Within treated areas, the research team observed a much higher rate of tree and shrub survival, as evidenced by unscorched crowns and new growth post-fire.

Figure 11 Looking west across the San Ysidro drainage to an area upslope of the San Ysidro Ranch. The right side of the photo shows where no thinning had occurred, and vegetation burned at high severity. By contrast, as the fire moved into the thinned area (left side of photo), the reduction of fuel reduced the intensity from a crown fire in the chaparral to a surface fire, reducing shrub scorch and mortality, thereby facilitating more rapid regeneration of understory grasses and robs due to the lower intensity.

- 6) Areas where vegetation had been thinned and/or converted to grass cover pre-fire were green with substantial new grass and other herbaceous growth four months post-fire. This in contrast to the more severely burned slopes where there are no discernable regeneration occurring as of April 2018 (See Figure 11 above).
