A DEFENSIBLE COMMUNITY?

A Retrospective Study of Montecito Fire Protection District's Wildland Fire Program during the 2017 Thomas Fire

October 23, 2018

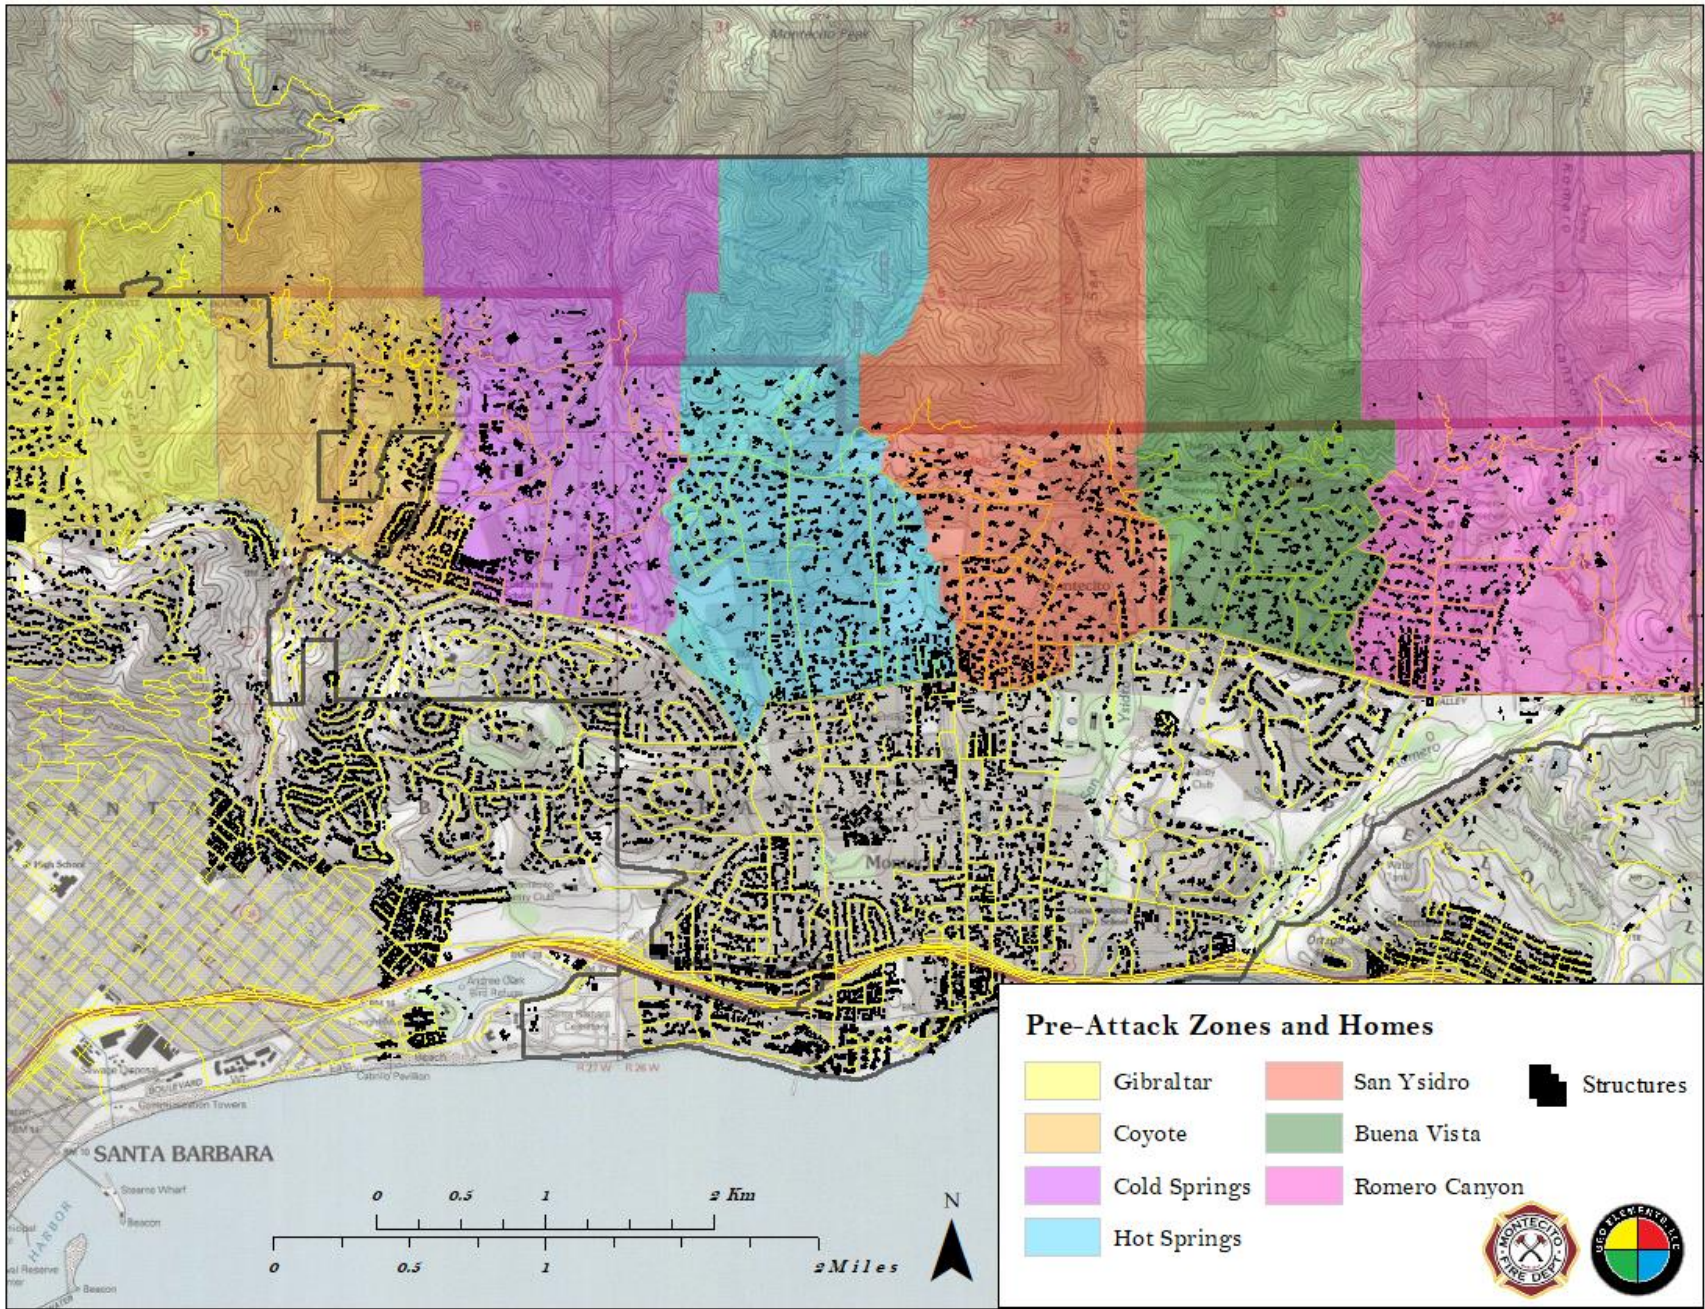
Figure 2 Pre-Attack Zones and Homes Map

Most housing in Montecito consists of single-family residences on lots that vary widely in size but are more tightly spaced in areas south of Highway 192. Increased lot sizes are found as one moves uphill from the village core, with most properties in the northern reaches of the community adjacent to the wildlands including both a main residence and a guest house, in addition to outbuildings, pool houses, and gated driveways (See Figure 2).

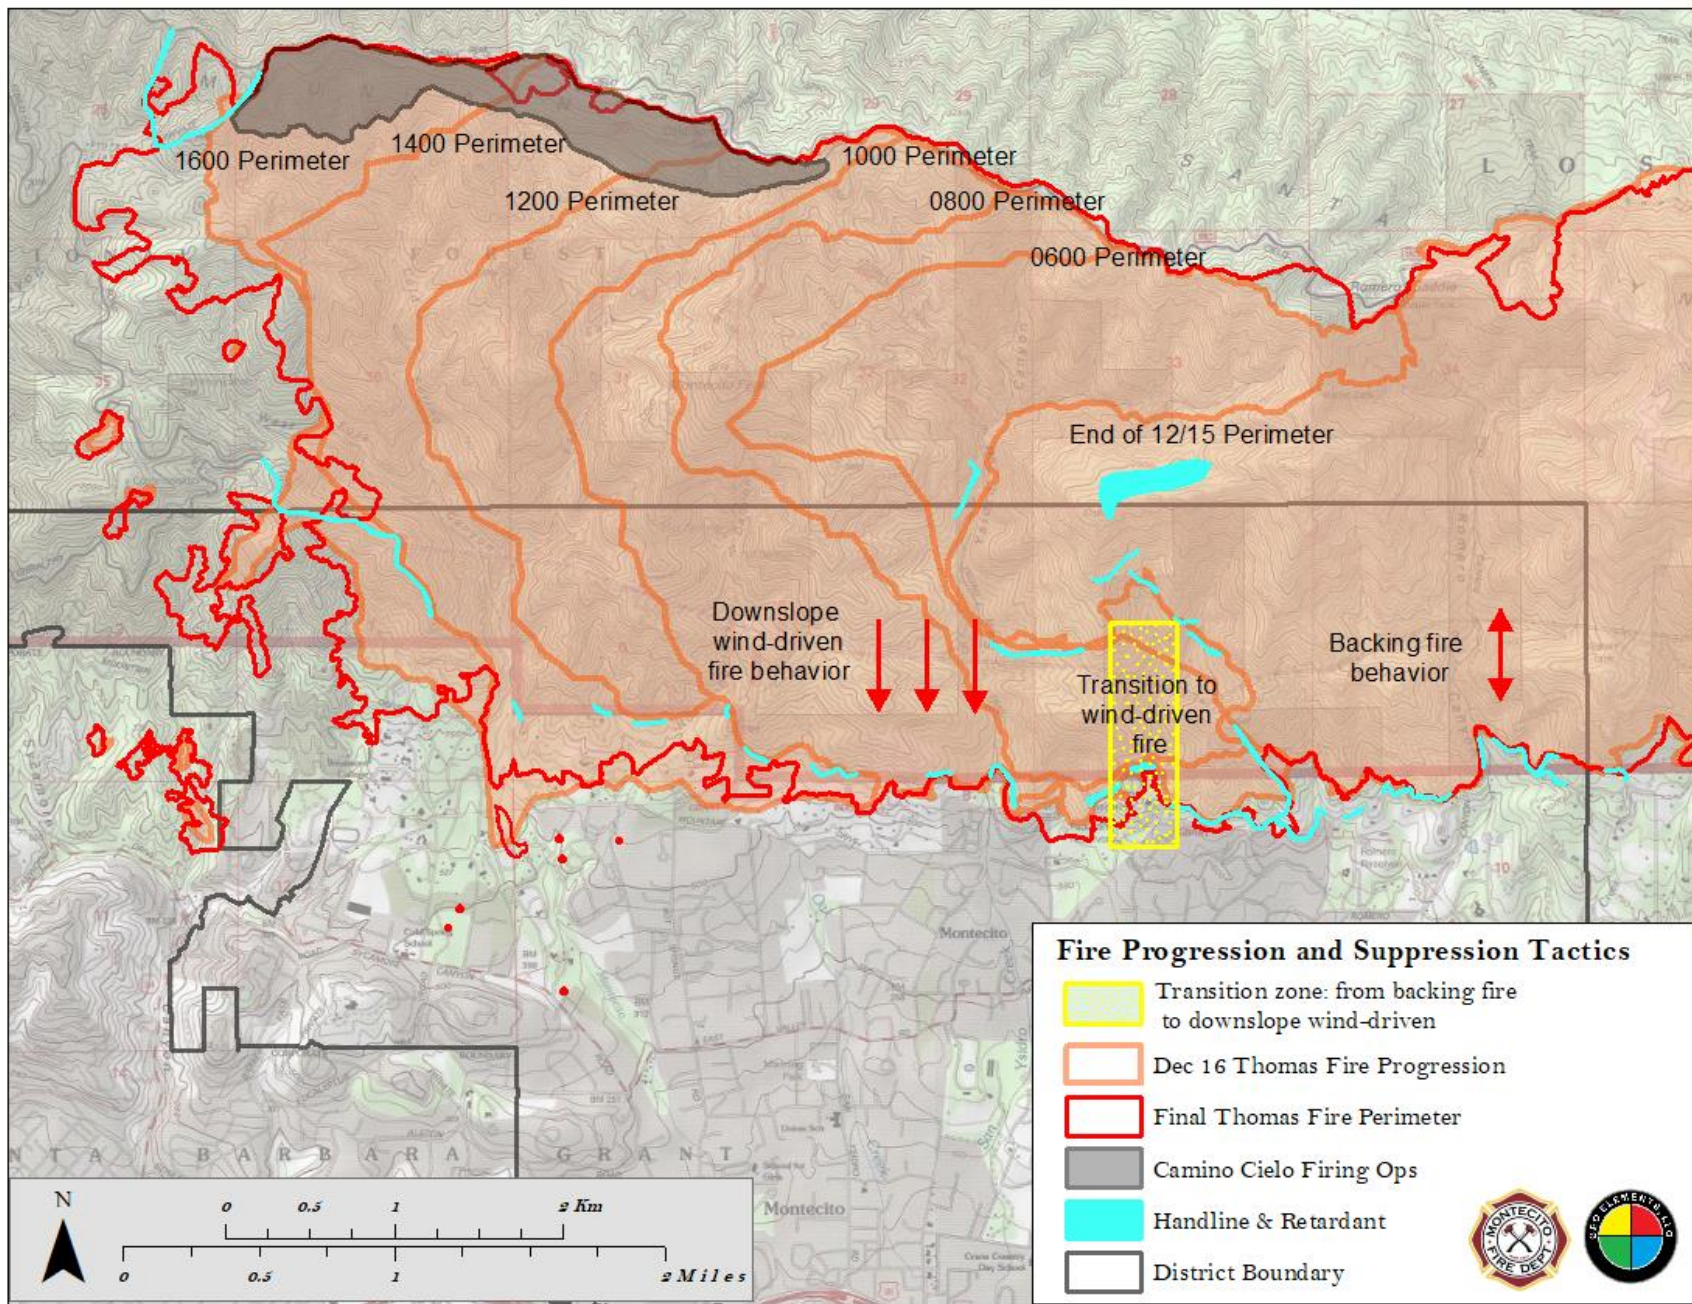
Figure 4 Fire Suppression & Suppression Tactics Map

Some suppression actions could be spatially documented from the Incident Action Plan and from high-resolution satellite imagery acquired on December 19th. By December 15th, indirect dozer line had been completed above Montecito, along the Camino Cielo Fuelbreak from Romero Saddle west to Paradise Canyon Road near Highway 154. Additionally, at least 7 miles of retardant line had been laid and over ¼ mile of hand line had been constructed in preparation for the fire moving towards Montecito (See Figure 4).

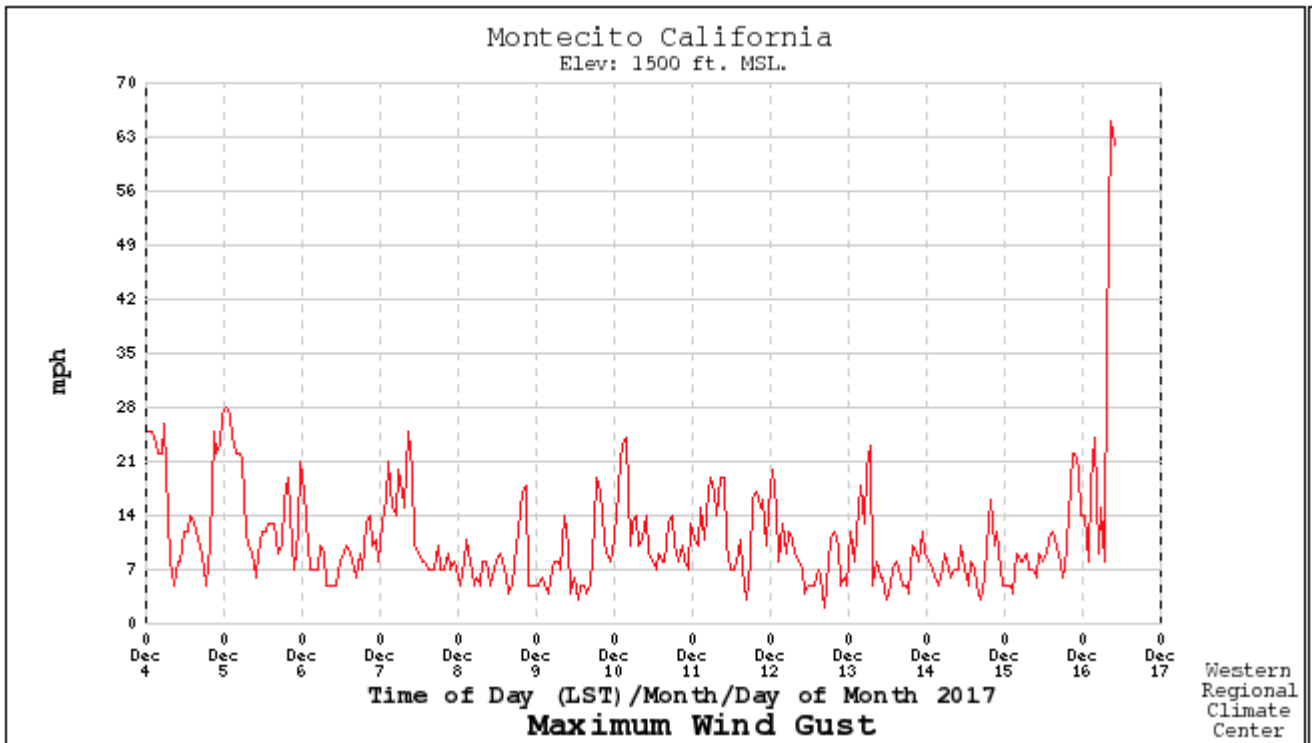
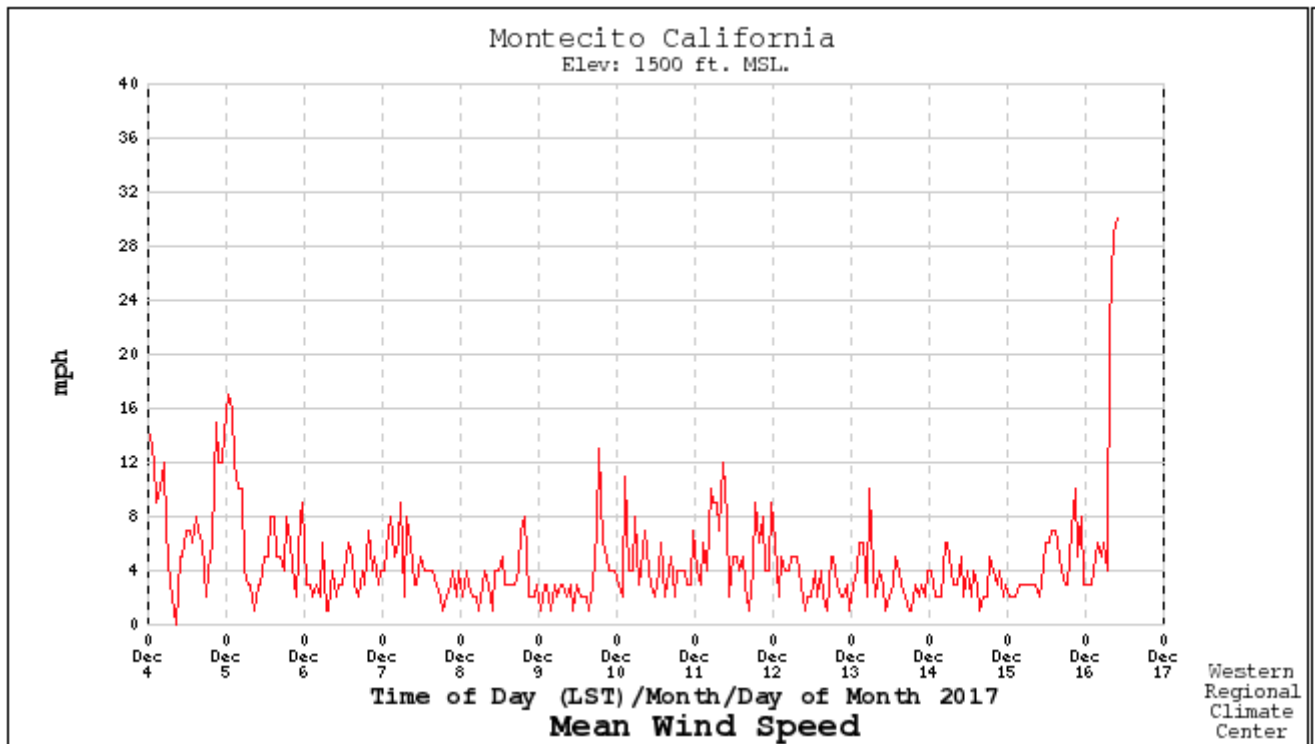
December 16th – As predicted, the Sundowner winds developed around 6:00 a.m., increasing fire behavior significantly in the Santa Barbara Front Country (See Figures 5 and 6). The winds created a fundamental shift in fire behavior, where what previously had been a lower intensity backing fire now became a wind driven fire spreading downslope with higher-intensity and with greater spotting distances.

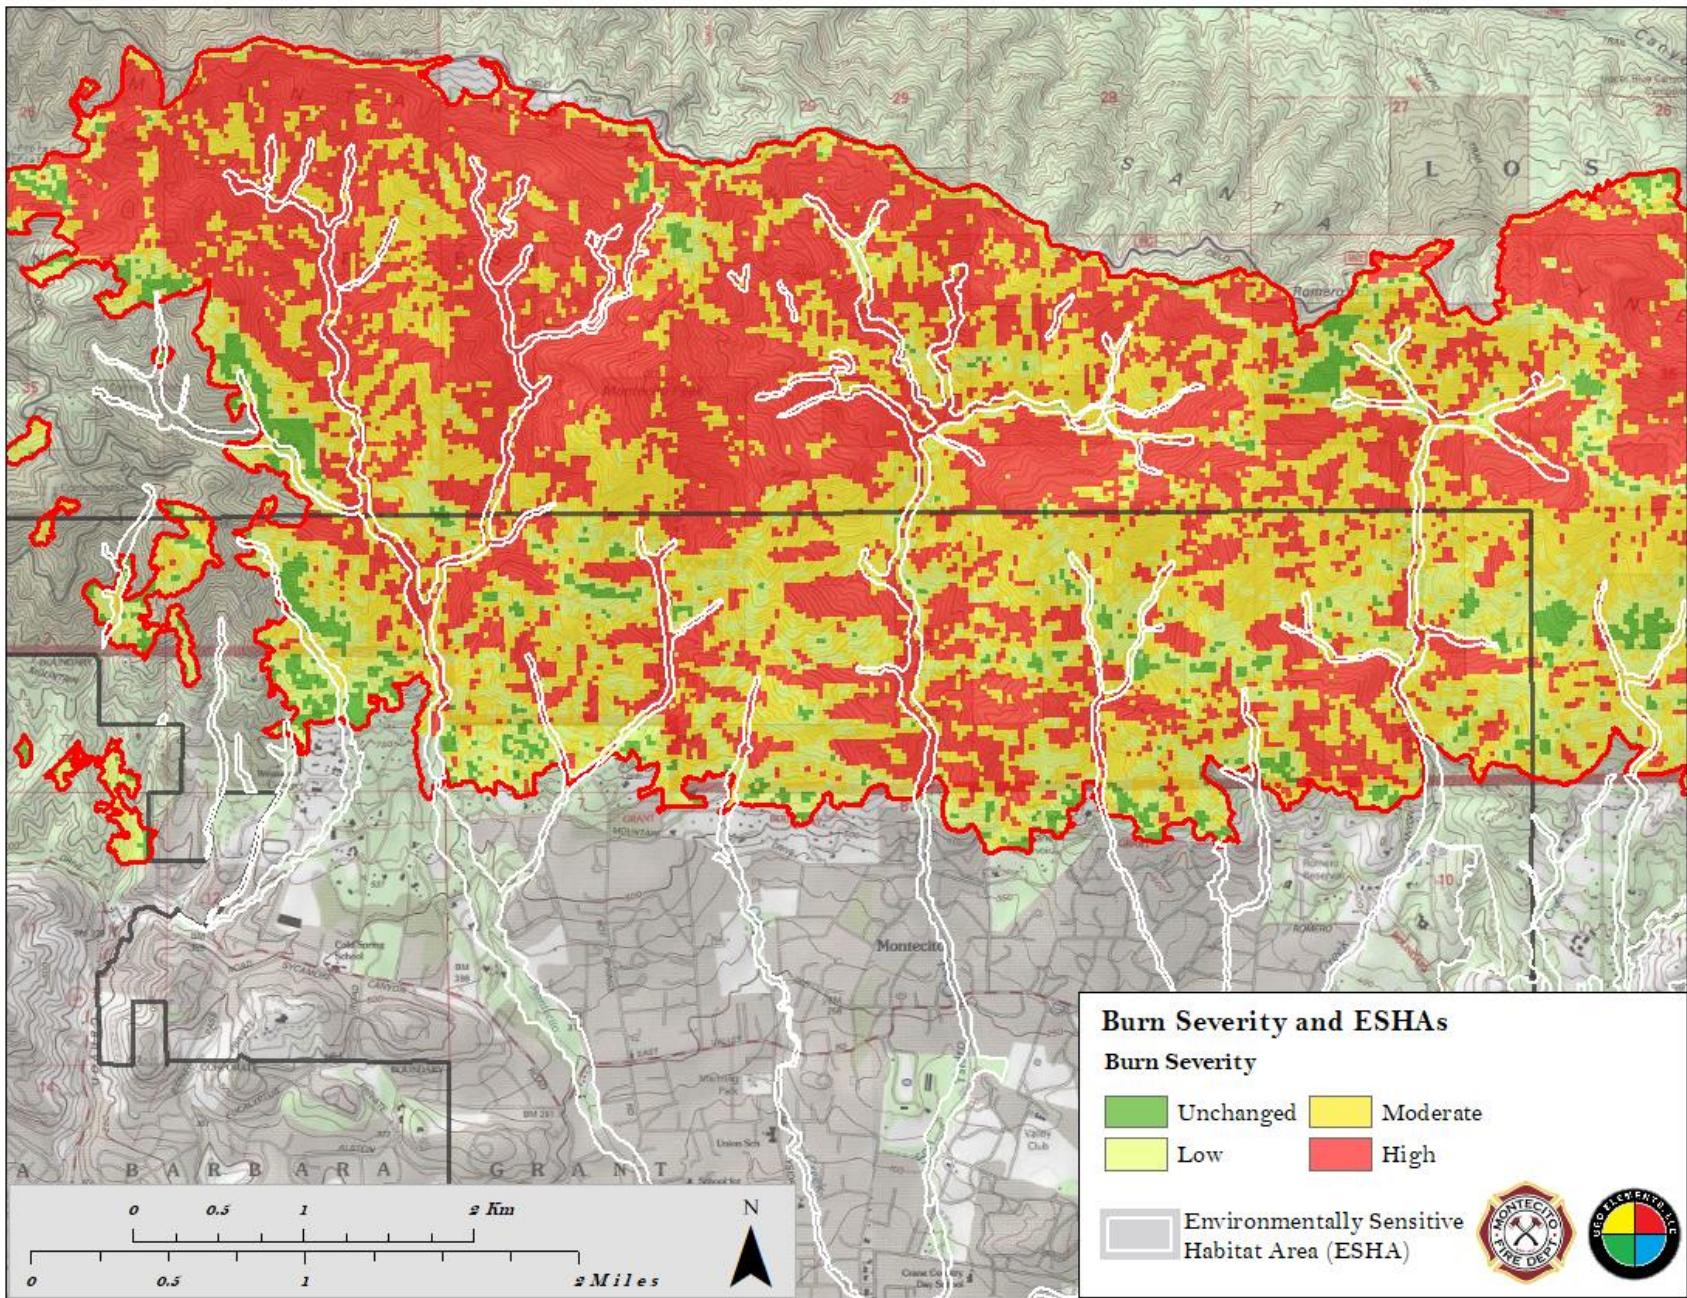
Figure 14 Burned area severity and ESHAs Map

ESHAs occur primarily in the riparian zones along the drainages that bisect the District. Burn severity mapping for the Thomas Fire and post-fire high-resolution satellite imagery indicate that the ESHAs burned predominantly at moderate to high severity, suggesting that habitat is likely compromised until sufficient regeneration and restoration occurs (See Figure 14).

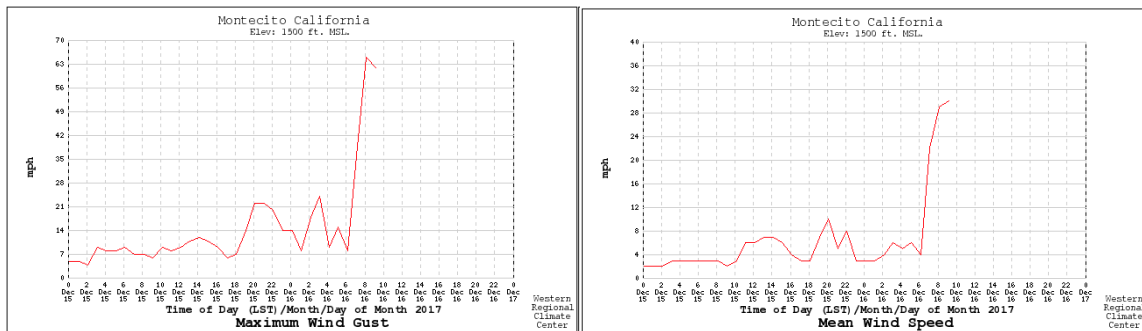
Figure 15 Sundowner winds maximum wind gust and mean wind speed

Wind inputs used in the CWPP analysis were consistent with data reported from local RAWS. A 60-mph wind from the north was used to model fire behavior in the CWPP analysis. Sustained winds of 32-mph and gusts of 65-mph were observed at the Montecito #2 RAWS when Sundowner winds developed the morning of December 16th (See Figure 15).

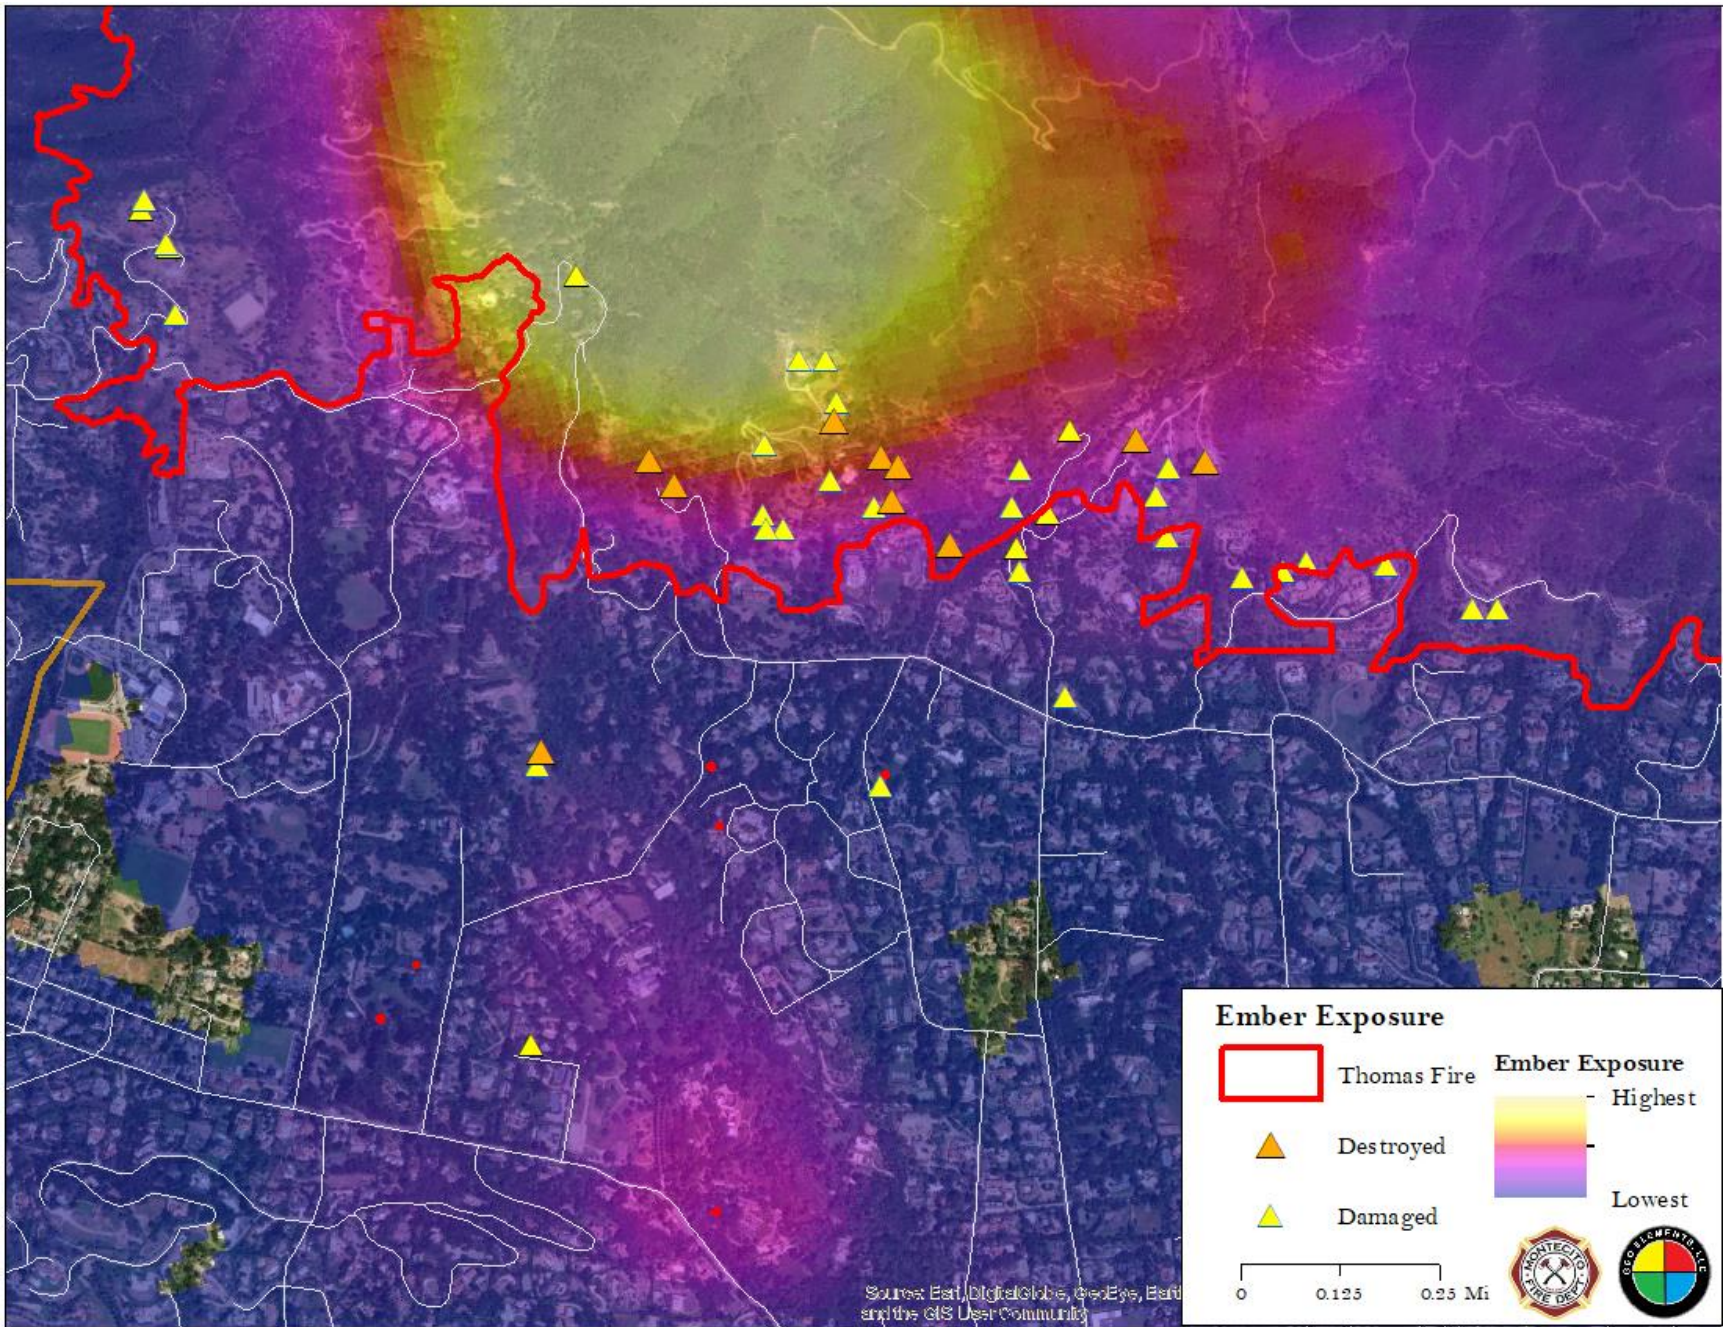
Figure 16 2016 CWPP Ember Exposure Zone Map

particularly as it is assumed that most damage to structures was associated with ember ignitions, and all damage observed outside/south of the fire perimeter was ember-ignited. The ember exposure model from the CWPP predicted that the highest density of embers would be received in a few key areas given a north wind of 60-mph. For the eastern half of Montecito, the Sundowner wind was not a factor, with a backing fire dominating fire behavior as the Thomas Fire intersected Montecito. Across the western portion of the community, however, the model was very accurate in indicating where the highest damage levels would be. One of the predicted peak ember density locations was the area between the Cold Spring and Hot Springs drainages, which is also where the highest density of destroyed and damaged structures occurred (See Figure 16).
